AN INVESTIGATION OF THE STUCCO MURAL OF THE WHARTON ESHERICK MUSEUM SILO: MATERIAL ANALYSIS AND CONSERVATION

Donglin Chen*, Andrew Fearon
Historic Preservation, The University of Pennsylvania Stuart Weitzman School of Design
dchen@trincoll.edu

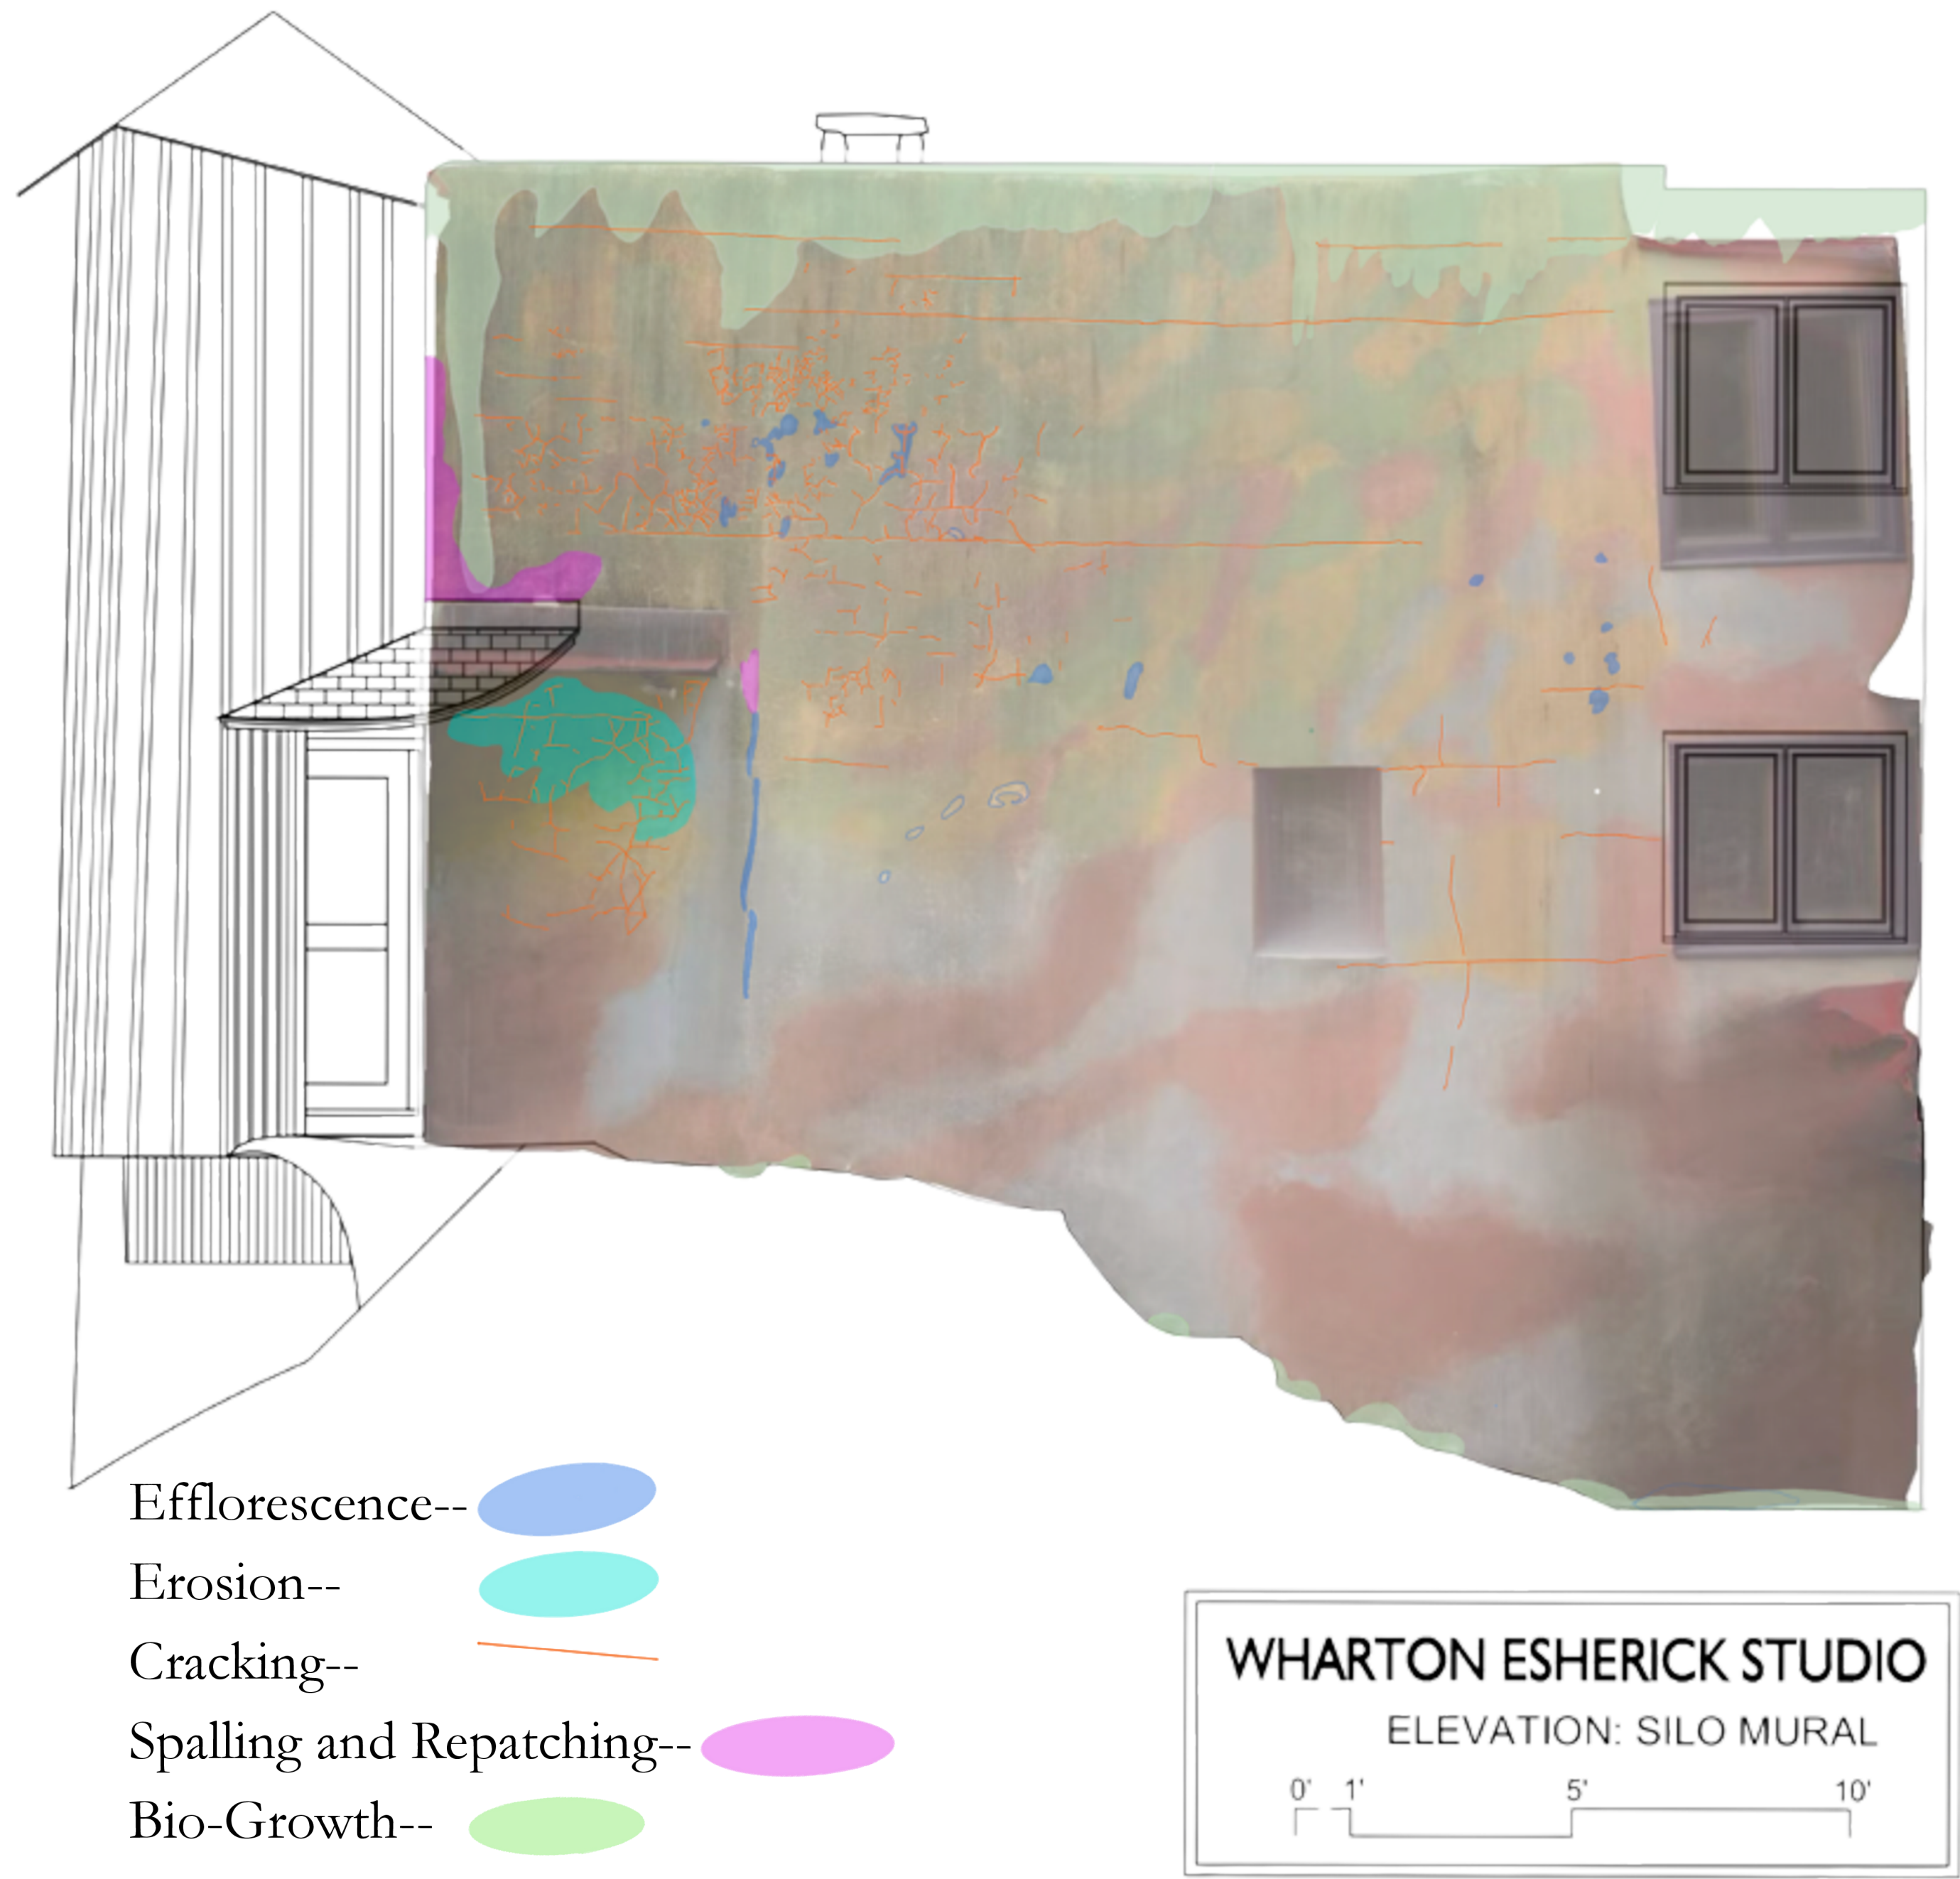
CONDITION ASSESSMENT

The exterior mural on the Wharton Esherick Silo shows advanced material degradation, primarily driven by prolonged environmental exposure and fluctuating moisture conditions. Field and visual assessments identified the following key deterioration patterns:

- Surface Erosion:** Extensive pigment and binder loss along the mural’s upper and western elevations, likely due to wind-driven rain and UV exposure.
- Cracking:** Fine network cracks and larger horizontal fissures are concentrated along transition joints and beneath overhangs.

- Efflorescence:** White crystalline deposits observed near the mural base and under the canopy suggest moisture infiltration and salt migration.
- Tape Adhesion Testing (ASTM D3359):** Revealed poor cohesion in many areas, especially where finish layers have thinned or flaked, indicating active delamination.

- RILEM Tube Water Permeability Testing:** Demonstrated high absorption rates in eroded and cracked zones, confirming compromised surface protection.
- Infrared Thermography:** Detected uneven thermal behavior, with cooler zones near cracks and moisture-prone areas—indicating water retention within the substrate.

- Soiling & Bio-growth:** Biological growth, particularly at junctions between the silo and studio, was observed prior to cleaning, often corresponding with damp or shaded areas.
